Bordley Township Project:

The fabric of Rylstone church (fieldwork visit 22-3-2010)

Notes by Alison Armstrong

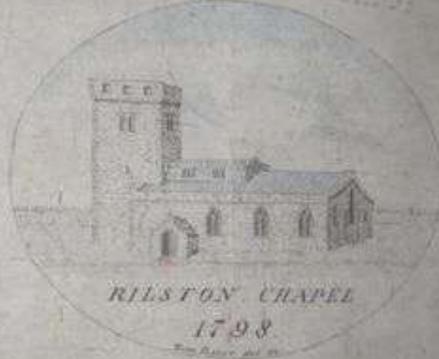
RILSTON CHAPEL
1798

THE STEEPLE

Containing Three Bells

seating as shown on the 1798 seating plan. The small sketch of the church has a prominent tower and the caption proclaims "The Steeple with three bells". Towers and bellringing were popular. The plan shows a 4-bay nave and a choir/chancel which is walled off from the chancel aisles. The SE chancel aisle is, significantly, labelled "hall quire repaired by the Duke of Devonshire." (This former chantry chapel site was inherited by the Devonshires from marriage to the Cliffords and by purchase from the Nortons of Rylstone Hall) The NE aisle area has the seating pew for Bordley Hall but is near the former chantry site. The seating plan is for box pews that no longer exist. The drawing shows a round-headed perhaps Norman porch door. There are stone crosses on the roof (perhaps including one now inside the church). The clerestory is depicted narrower than the tower and only of two bays which seems curious, but might be artistic licence. Perhaps the old, narrow and short, Saxon or Norman nave remained?. A great crack drawn down the SW corner of the aisle suggests need of repair. The abundant 18thC gravestones now used as paving around the exterior 19thC walls and in the church floor show the popularity of the 18thC church by Bordley residents.

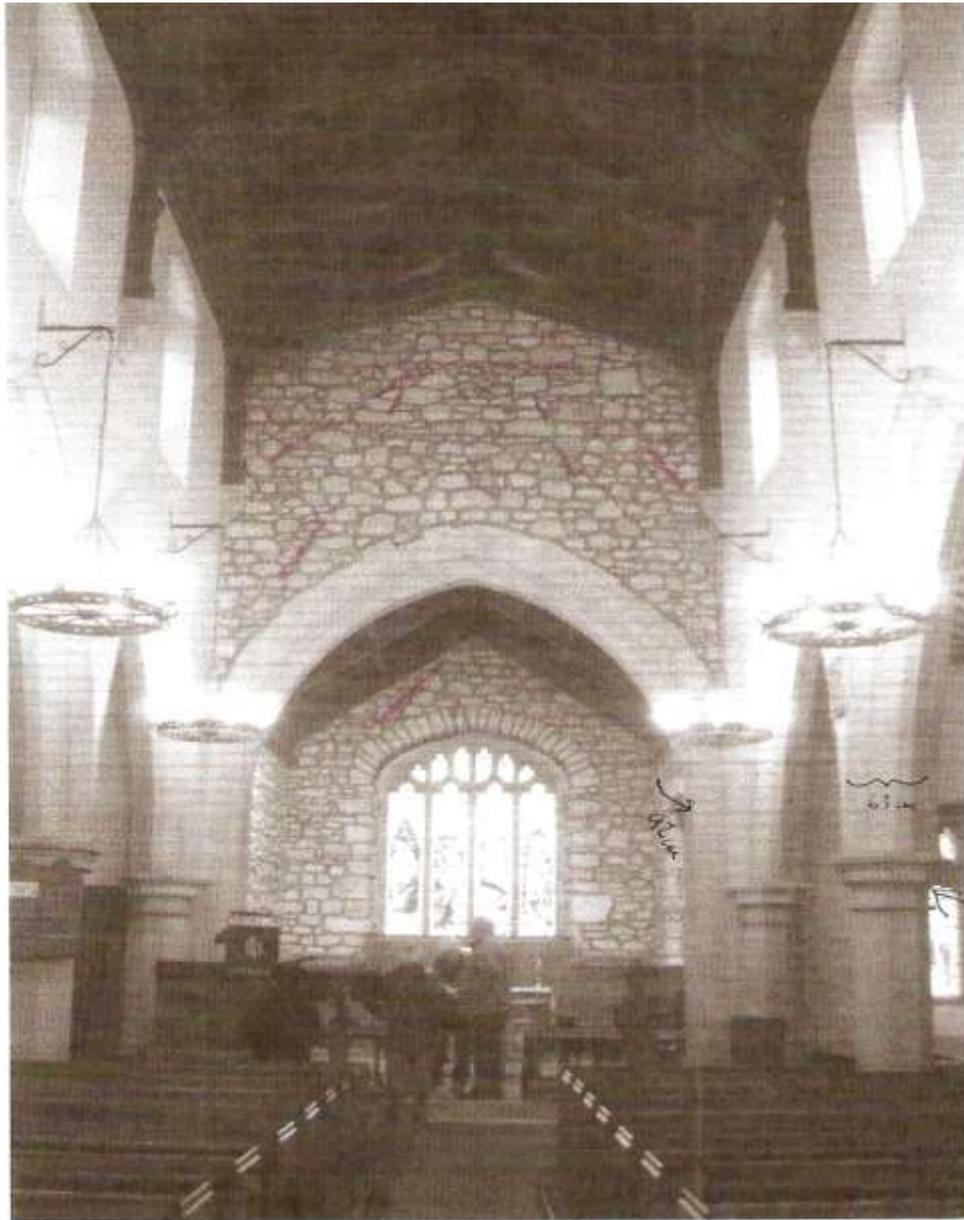
RYLSTONE CHURCH

Red lines show earlier rooflines of chancel/nave.

5 Chancel arch and chancel rooflines (See illustration below)

The chancel arch and chancel are the only parts of the interior now clear of plaster. the chancel arch was still painted with a design in the late 19thc. The walls now reveal rough stonework of roughly coursed boulders which is certainly not 19thc work. The dressed stonework of the east window appears to be added onto the outside of an earlier wall in an enlarged opening and the 19thc dressed work is not carried through the wall opening to the interior in the normal way. The chancel arch shows two earlier roof lines. The first is very steep and tall and may have belonged to a narrow Saxo-Norman chancel arch or east end without aisles, or with very narrow aisles. Above this is a higher flatter roofline reaching down to the base of the clerestory. This might be the wide and shallow roof shown in 1798 designed to cover the wider medieval aisles.
